HOBAS NC Line

HOBAS NC Line - for Pipes with a Non-Circular Cross-Section

HOBAS NC Line are glass-reinforced polyester (GRP) pipes manufactured using the filament winding process and designed for constructing or rehabilitating non-circular sewers. An ideal solution for such applications, these special pipes can be made to fit inside the old sewer for rehabilitation or in virtually any shape required for new installations. Consisting of polyester resin, quartz sand and glass, the pipes are manufactured to DIN 16868 Part 3.

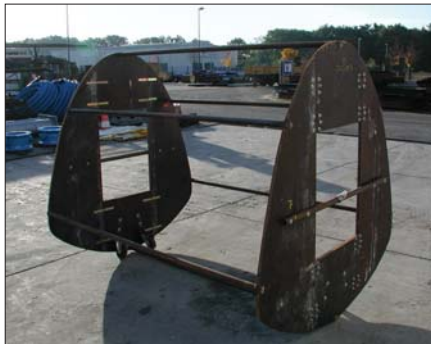
Pipe calibration template

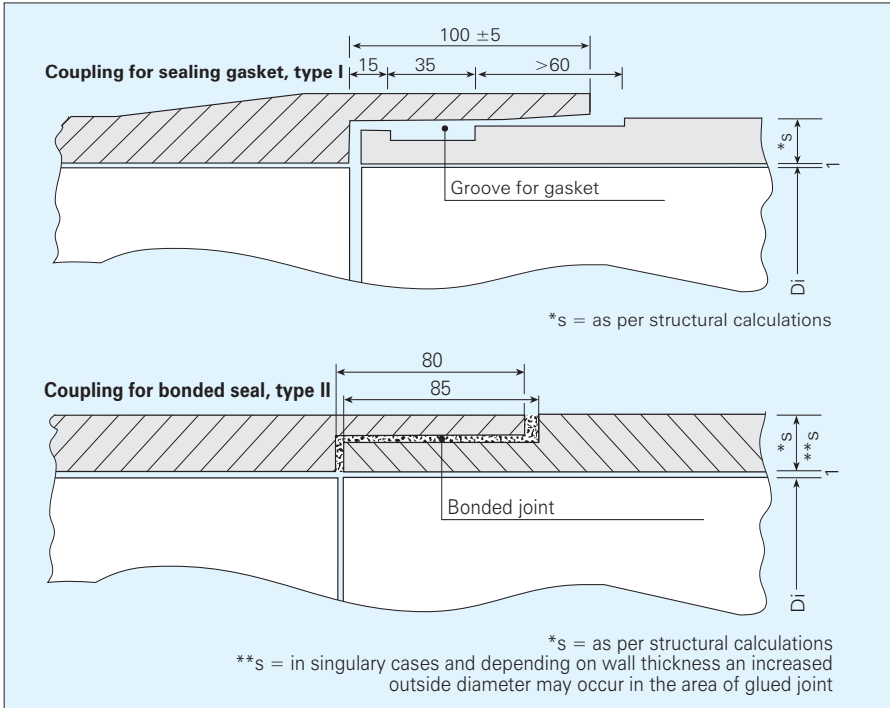
Joins

During the winding process, all the HOBAS NC Line Pipes are also fitted with a sleeve coupling at one end, which has an elastomeric sealing gasket to DIN 4060. After this process is completed, the spigot is milled. An adhesive joint is also available for special applications.

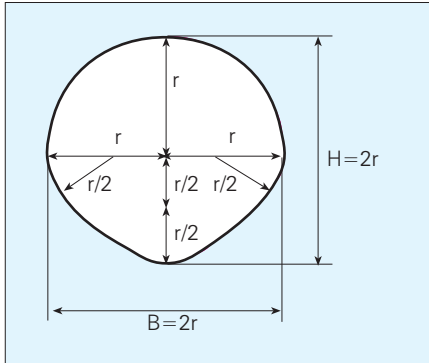
| DN | Theoretical cross section mm | A sq m | L m |
| 1,600 | 1,543 | 1.869 | 3.00 |
| 1,800 | 1,736 | 2.366 | 3.00 |

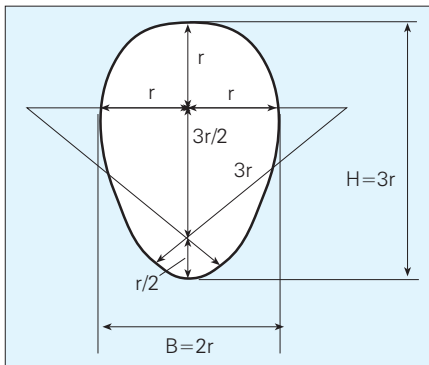
| DN | Theoretical cross section mm | A sq m | L m |
| 300/500 | 407 | 0.130 | 2.50 |
| 680/1050 | 875 | 0.561 | 3.00 |

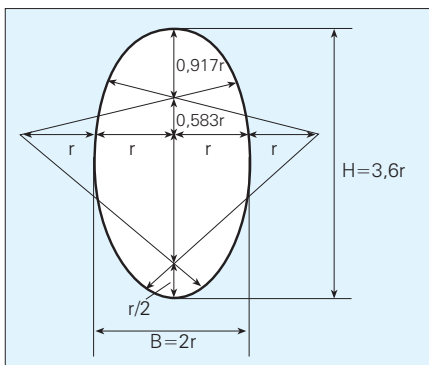
| DN | Theoretical cross section mm | A sq m | L m |
| 480/800 | 650 | 0.32 | 2.60 |

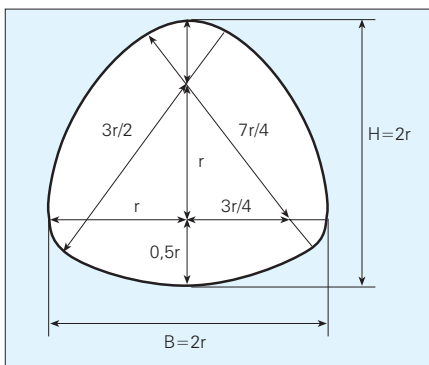
| DN | Theoretical cross section mm | A sq m | L m |
| 1360/1570 | 1469 | 1.596 | 2.00 |
| 2680/2590 | 2618 | 5.170 | 2.30 |

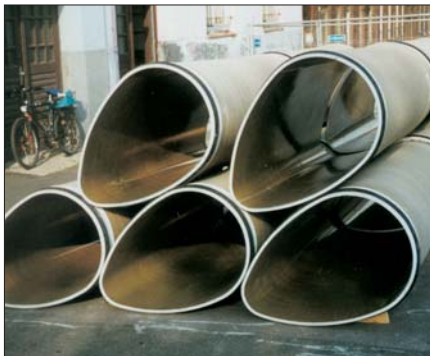
HOBAS NC Line Products DN 680/1050 for Relining stored in front of the access shaft

structural dimensioning of the liner. Egg-shaped DN 680/1050 pipes with a wall thickness of 10 mm were selected for rehabilitation. They were inserted separately into the old sewer through a short shaft at the end of the relining section. After being joined, each pipe was prevented from floating at the crown of the old sewer.

The lengths of 2.0 m and 3.0 m combined with the simple jointing system enabled the liner pipes to be laid rapidly. As a result, installation was completed within six days. The storm sewers from the various properties were connected to the interceptor with laminate hand lay-up. To check leak tightness, the liner was then filled with water. Finally, the remaining annulus between the liner pipe and old sewer was completely filled with special cement (grout).

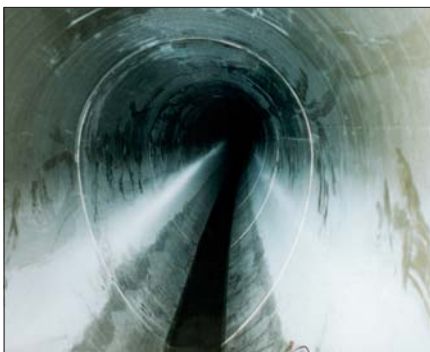
View into the rehabilitated sewer

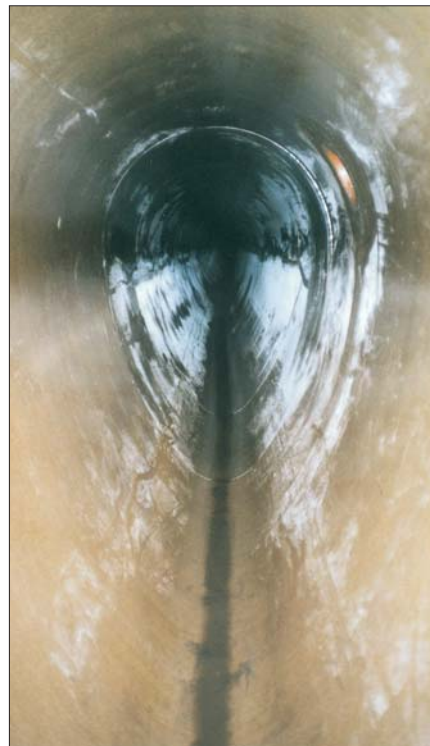
Rehabilitated sewer with DN 200 laminated inlet

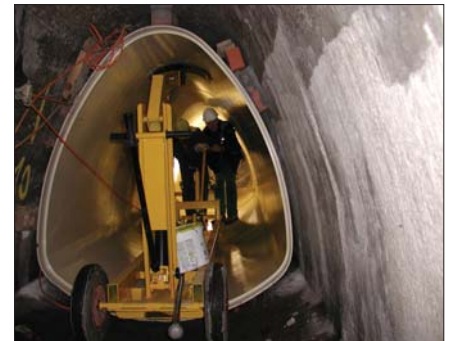
HOBAS NC Line pipe installation

The HOBAS pipes were joined with push-on couplings bonded in place by laminate hand lay-up. Precautions were also taken during installation to prevent flotation. After tightness testing to DIN EN 1610 procedure „W“, grout was injected section by section.

Intensive use and high traffic loads in the Berlin district of Steglitz-Lichterfelde Ost resulted in deterioration of a concrete storm-water sewer (hood cross-section 1560x1770 mm). In view of the damage detected and the load conditions, the HOBAS NC Line Pipes were calculated on the basis of „old pipe condition II“ to ATV M 127 Part 2. They were then manufactured using a calibration template that was a replica of the old pipe shape. Two-meter lengths were laid in the straight sections of the sewer and one-meter lengths in the curved sections.
